APPLICATION OF VIBRATION DIAGNOSTICS IN EVALUATING INDUSTRIAL SAFETY OF COMPRESSORS

R. V. Zhukov, V. M. Davydov, V. V. Grib, M. V. Korolkov OOO NPP Mechanic, Moscow, Russia Moscow Automobile and Road Construction Institute (State Technical University), Moscow, Russia

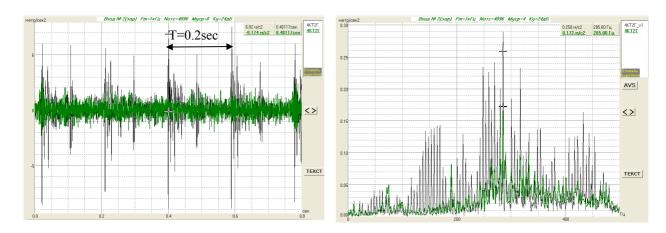
After 5,146 hours of operation of the repaired compressor, a decrease in the vibration level was observed in time realizations. Sub-harmonics almost disappeared in the envelope spectrum. At 285 Hz, the level of vibration decreased 1.8-fold. The 1st harmonic vibration level also decreased 1.7-fold. All this indicated that the components were aligned. No damage of the liner and seating-in signs on the shaft were detected during the next scheduled repair of the assemblies.

Fig. 2 Time Realizations and Vibration Acceleration Spectra of NA-20 Compressor, Position

No.35-II (measured when the compressor ran idle):

before repair of the bearing;

after repair of the bearing

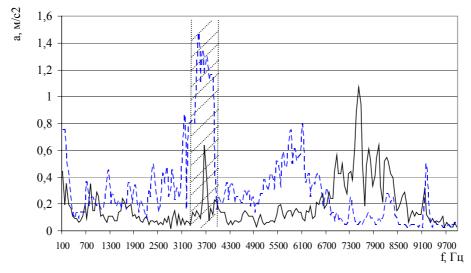
Below are some results of examination of a TV2S3K-400/630 nitrogen compressor installed at Azot Chemical Plant in the large-scale separation of residual gases resulting from ammonia synthesis. The compressor's specifications are as follows: output of 110 m³/min, final discharge pressure of 10 MPa, motor power of 800 kW, rotational shaft speed of 293 rpm. In the course of the machine overhaul, gaps were examined in all bearings, crosshead slide assembly and cylinder-piston block. In the course of examination of the compressor during the entire repair cycle (3 years) being recorded were vibration spectra, which indicated various levels of wear of the assemblies. The report shows spectral characteristics of vibration for the assemblies under consideration (Fig. 3).

Fig.3 Spectra of Vibration Acceleration of Cylinder-Piston Block of TV2S3K– 400/630 Compressor

– – 0.6 mm gap in cylinder-piston block;– – – 2 mm gap in cylinder-piston block

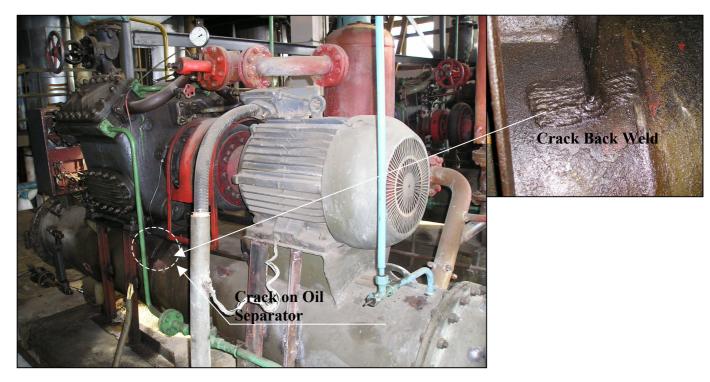
The report shows the instances where cracks occurred in places where a compressor unit frame was welded to a tank. As an example, Fig. 4 shows a system incorporating 2P-110 compressor. There also were some cases when fatigue cracks occurred in the similarly designed systems incorporating screw ammonia compressors.

Fig. 4 Compressor Unit with Crack on Tank

Special attention should be paid to expert evaluation of compressor plants, in which a pressure tank is used as a support frame. Typically, such design is a screw type (less frequently, a piston type) refrigerating ammonia compressors and also in mobile piston air compressors. The tank experiences high cyclical loads induced by vibration of the compressor and the motor. High inertial forces cause cyclical deformation of the tank in sections where supports are welded, which facilitates occurrence of cracks in these places and leads to weakening of the motor-compressor system stiffness. This, in its turn, leads to quick misalignment of shaft axes and premature failure of driver antifriction bearings. Experience of examination of compressors mounted on tanks shows that in the course of technical diagnostics one should use a program (methodology) that takes into account all aspects and specificities of the system operation. Additional inspection of the shell section to which compressor and motor support feet are welded is required. It is also necessary to systematically monitor the vibration state of a compressor.

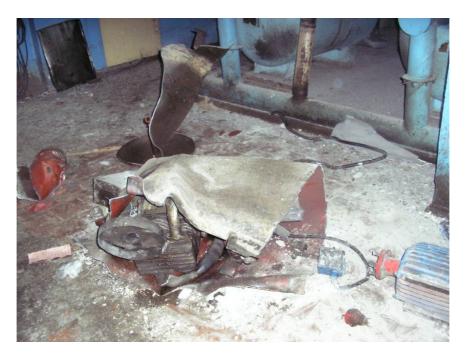
OOO NPP Mechanic experts took part in investigation of the accident root-causes. In the process of examination, the following was found out. The receiver body was destroyed mainly along the welded joints, and the receiver shell plate was torn and rolled outside (Fig. 5). The fact that all welded joints were destroyed precisely along the thermal effect zones indicates high enough quality of welding work performed on the tank. Macro-examination of the fracture surfaces did not reveal any major defects in the joints and confirmed that they had the fine-grained structure. Absence of plastically deformed metal on fracture edges definitely indicated a brittle nature of fracture. The drive end of the compressor crankshaft was cut at the fillet connection point. Macro-examination of the cut section of the crankshaft showed that it had the structure typical for a brittle facture. Large quantity of oil crust was detected in the valve chamber from the I stage side as well as on the inner surface of the discharge pipe of the I stage. The paint and lacquer coating of all pipes was burned, which indicated that they had been exposed to high temperature. The back-flow valve installed on the discharge pipe of the II stage was destroyed. The pressure-relief valves of the I and II stages were torn off the sockolets.

Fig. 5 Compressor Unit after Destruction

The practical operation of air compressors [5] shows that there is a hazard of ignition and explosion of oil crust accumulated in a cylinder and pipes. It may happen if a discharge temperature exceeds the values specified in the "technical passport'. In this particular case, it could occur when the compressor unit was operating with almost closed valve at the receiver air outlet. Thermodynamic calculations of the compressor showed that the discharge temperature of +190°C, at which self-ignition of oil crust occurs, was reached in the I stage cylinder when the final pressure was 14 kgf/cm². And the motor was powerful enough to enable the compressor to produce such pressure.

Calculations of strength of the receiver's shell (at 14 kgf/cm²), along welded joints of which fracture occurred—with allowance for inner pressure, the minimum wall thickness and degradation of mechanical properties of metal heated up to +200°C—showed that strength of the tank was

ensured. At 14 kgf/cm², the receiver could not be destroyed without being affected by other factors. The tank completely lost its strength at a pressure of not less than 26 kgf/cm².

Therefore, destruction of the air receiver resulted from ignition of oil crust in the cylinder of the first stage of the compressor and the follow-on explosion of oil mist in the receiver.

Thus, in the case of these systems, it is necessary to evaluate industrial safety of both the compressor and tank as a whole.
