# **Role of Weld root Geometry – Backing rings in Flow Accelerated Corrosion (FAC): Radiography testing is an alternate NDT method for detection - An experience at Tarapur Atomic Power Station-1&2; Nuclear Power Corporation of India Limited, India**

*Tarapur Atomic Power Station -1&2, Nuclear Power Corporation of India Limited*

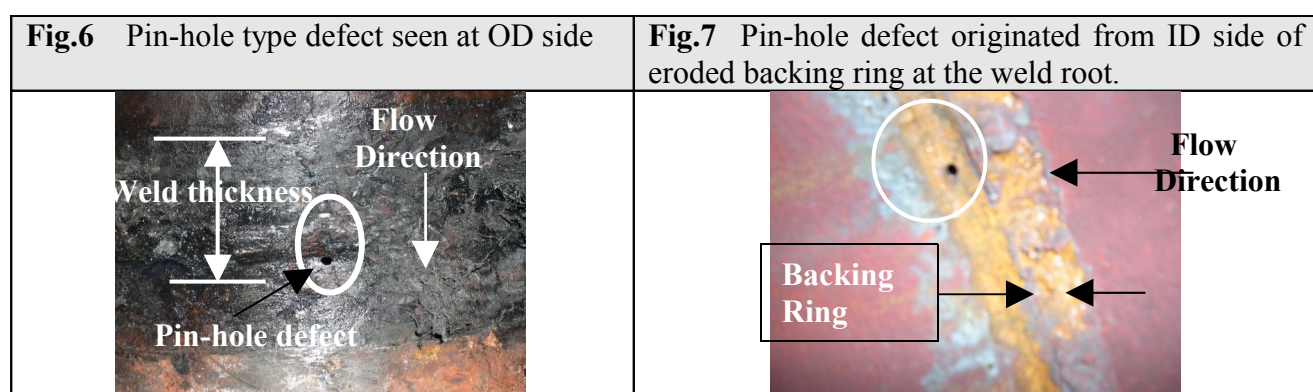
- 7.1 One of the component in condensate feed water system developed pin-hole leak at/adjacent to downstream of weld toe while the unit was at full power operation of 160MWe. This component is located at down stream of Low pressure Feed Water Heater. **Table-2** gives the component details. Detail failure analysis has been performed by the in-house expertise and flow turbulence/disturbance due to eroded backing ring at weld root is identified to be the root cause of failure. Various NDE methods were utilized to establish the detection capability of such degradation mechanism.

| Description | Details |
|---|---|
| Defect location & size | @6'o clock position INTRADOS; 2mmØ |

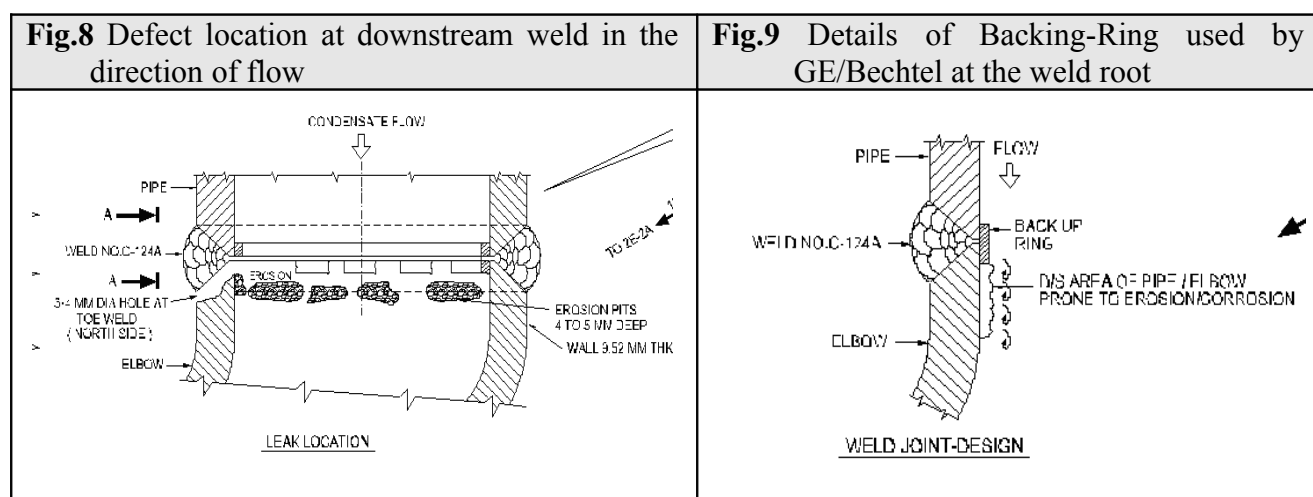
7.2 As per the GE's design, GE/Bechtel's welding procedure all the weld joints of condensate & feed water system are followed with back-up rings at the root (refer **Fig.8& 9** for details). This backing ring is of split-flat type and of similar material as that of the base material. It is fitted with spacers (knock-off pins/fusion nubs).

13.2 Use of backing rings **has been eliminated**, instead GTAW process has been incorporated for better weld quality at the root to eliminate flow disturbances, thus material loss by erosion, one of the influential factors of FAC.

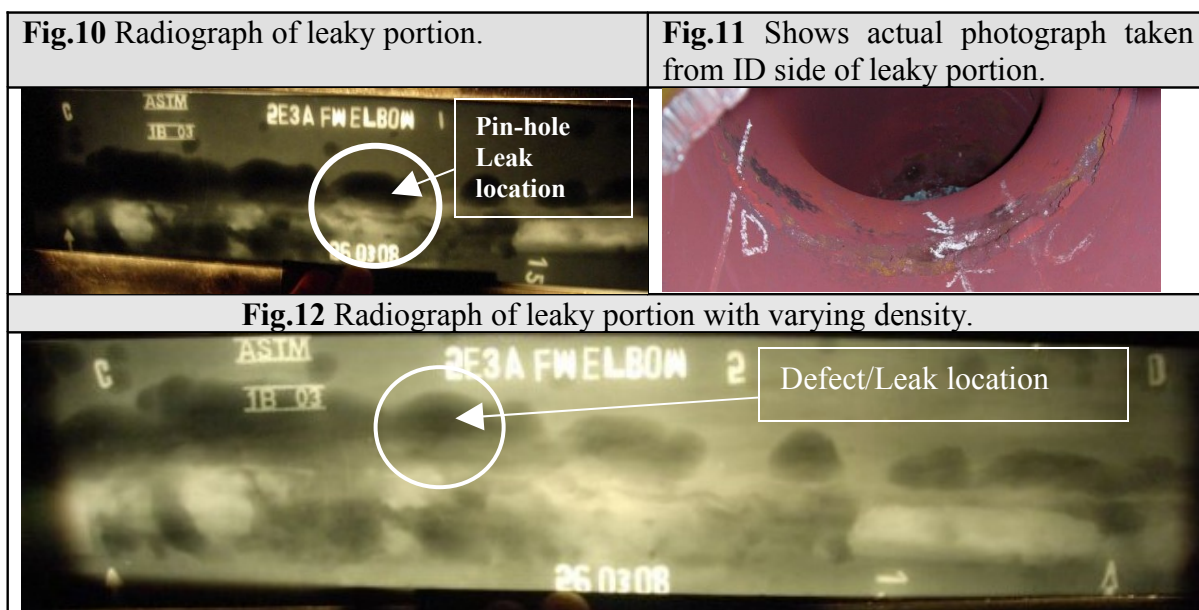
- 8.4.1 Some of the overseas nuclear power plants have indicated in their FAC detection & monitoring programmes that Radiography Testing (RT) can be one of the NDT methods that can be used to detect the degradation. Therefore, an experiment was made to correlate the data vis-à-vis visual observations. In radiography testing, change in density would give qualitatively about the condition of piping component (ID) and weld condition at & adjacent root. Radiographs were exposed at varying densities. From the review of radiographs it can be interpreted the material loss at the root & also at adjacent to the weld root. Fig.10 to Fig.11 shows the radiographs and actual photographs for comparison purpose.

8.4.2 Radiography testing of base material was also taken up to study the erosion pattern. The erosion could be identified and are compared with respect to the visual examination observations. The density of films at weld varies from 2.0 to 3.0 and it was observed that the indications are interpreted with a reasonable confidence level at an average optical density of 2.0.

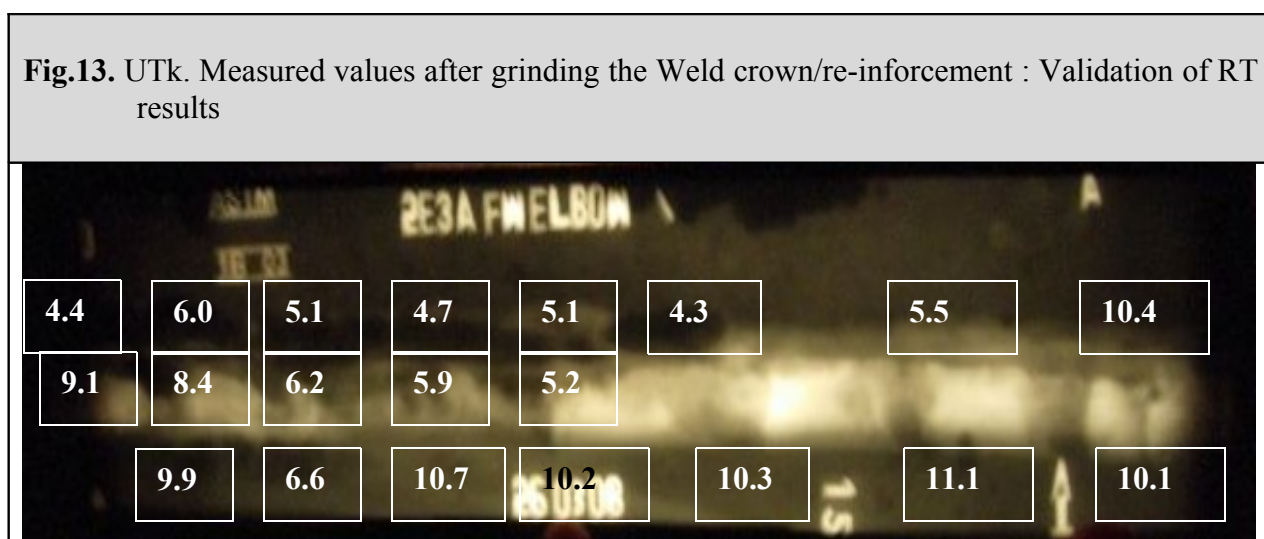
9.1 Erosion was noticed at the weld centerline as well as at the weld toe from ID. Thickness measurement at weld toe **could not** be carried out due to the presence of weld crown/reinforcement. To facilitate UT thickness gauging on weld and weld toe, some portion of the weld was ground flush with the parent metal at OD. Thickness measurement at a span of 25 mm was carried out and the results are as follows:

9.2 Thickness measurement was carried out with DM-4 thickness tester. After grinding, thickness could be measured at weld centre and weld toe successfully. These values are comparable and co-related with the observations made in the RT (Density variation due to material loss).

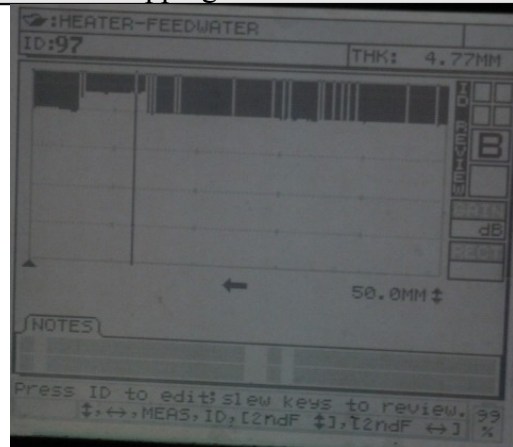
10.1 In addition to the above, B-Scan facility has been successfully utilized in detecting the material loss of carbon steel piping components. This technique is being used once the area of concern is detected & identified by either RT and/or ultrasonic thickness gauging. Further scanning the area with closed grid spacing, with UT instrument having B-Scan facility is an added advantage to monitor the component condition for fit-to-service evaluation. Some of the components were monitored with this enhanced UT technique and could detect the component degradation effectively. This technique will be employed in critical areas in future inspections.

**Fig.15** B-Scan technique for corrosion mapping

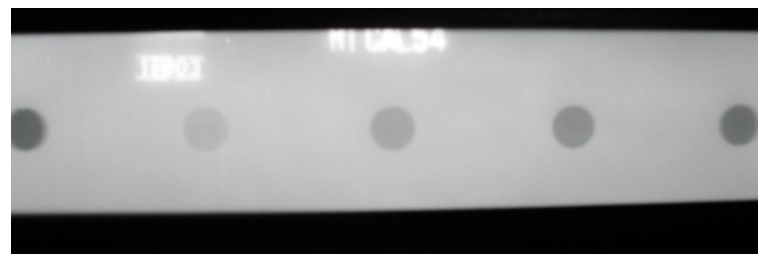
**Fig.16** RT Calibration reference with known material loss data (20%; 40%; 60%; 80% & 100%)
