# THE ULTRASONIC TOMOGRAPHY TESTS OF CONCRETE IN FOUNDATION SLAB

## Abstract

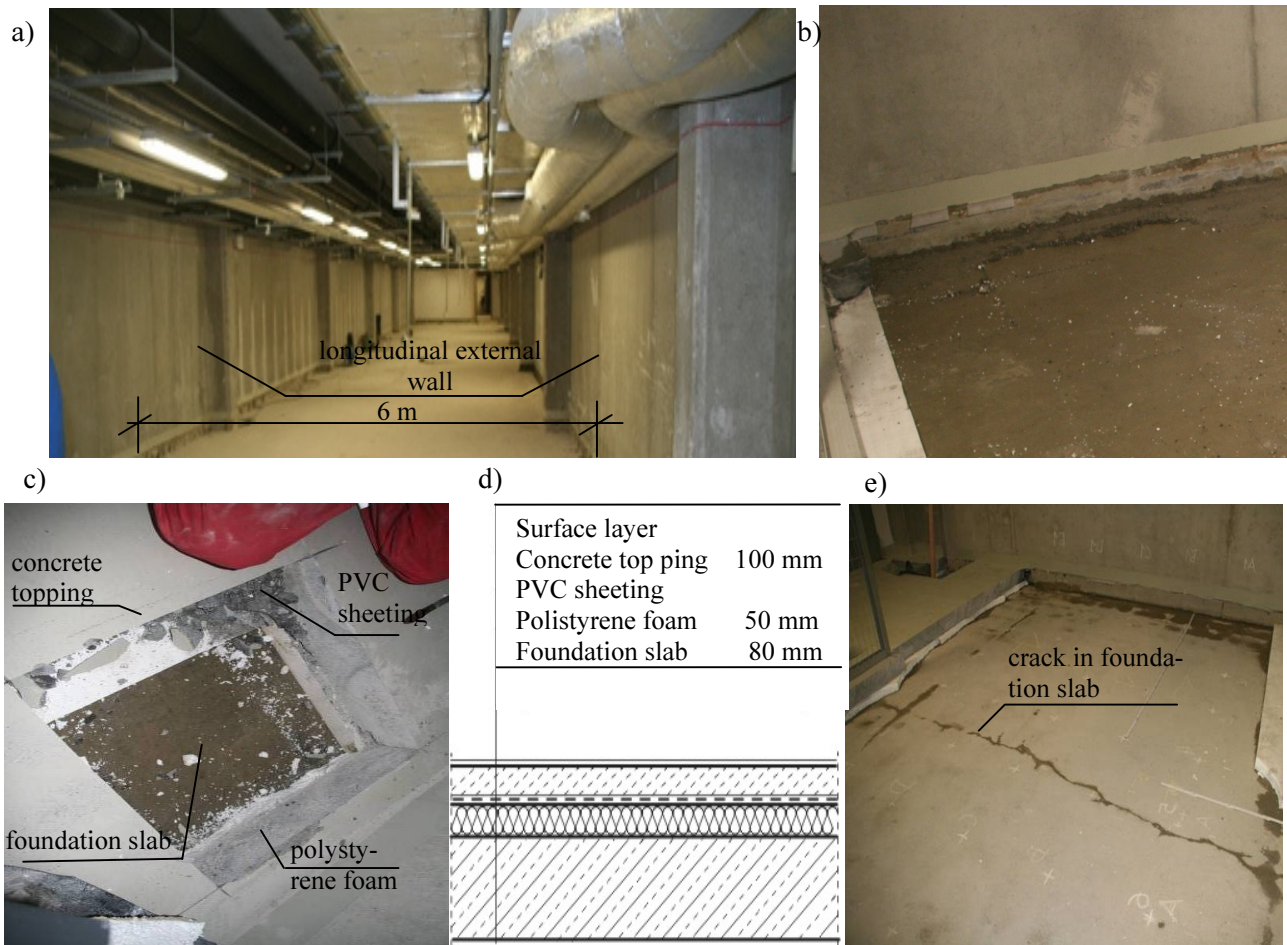
Soon after the building was put into service, water appeared on the floor in one of the rooms in the 100.00 m and 6.00 m wide basement storey (fig. 1). The water leaked at the concrete floor/longitudinal walls contact. In the part of the room in which the leakage was most intensive a test pit of about 0.50 m<sup>2</sup> was made in the finishing layers near one of the longitudinal walls. The test pit revealed water on the surface of the foundation slab and in the polystyrene foam layer (fig. 1b). Therefore a decision was taken to make a large (ca 20.00 m<sup>2</sup> in area) pit extending over the entire width (6.00 m) and length (3.00 m) of the room (fig. 1). After the topping, the sheeting, the polystyrene foam (fig. 1) and the water were removed and the groundslab surface was quickly dried over the pit's whole length (3.00 m), a crack with wide 1.0 mm became visible near the middle of the slab span (fig. 1d). Water was leaking out of the crack. In order to determine the length of the crack, a ca 1.00 m wide bandlike pit was made in the line of the crack. It was found that the crack in the foundation slab extended for about 50.00 m. Then it became clear that the water was leaking through a long fracture which appeared in the foundation slab.

Fig. 1. View of rooms in the basement storey and location of pits in foundation slab: a) general view, b) approximate saturation with moisture floor, c) view of test pit, d) cross-section of the flooring layer, d) view of large pit

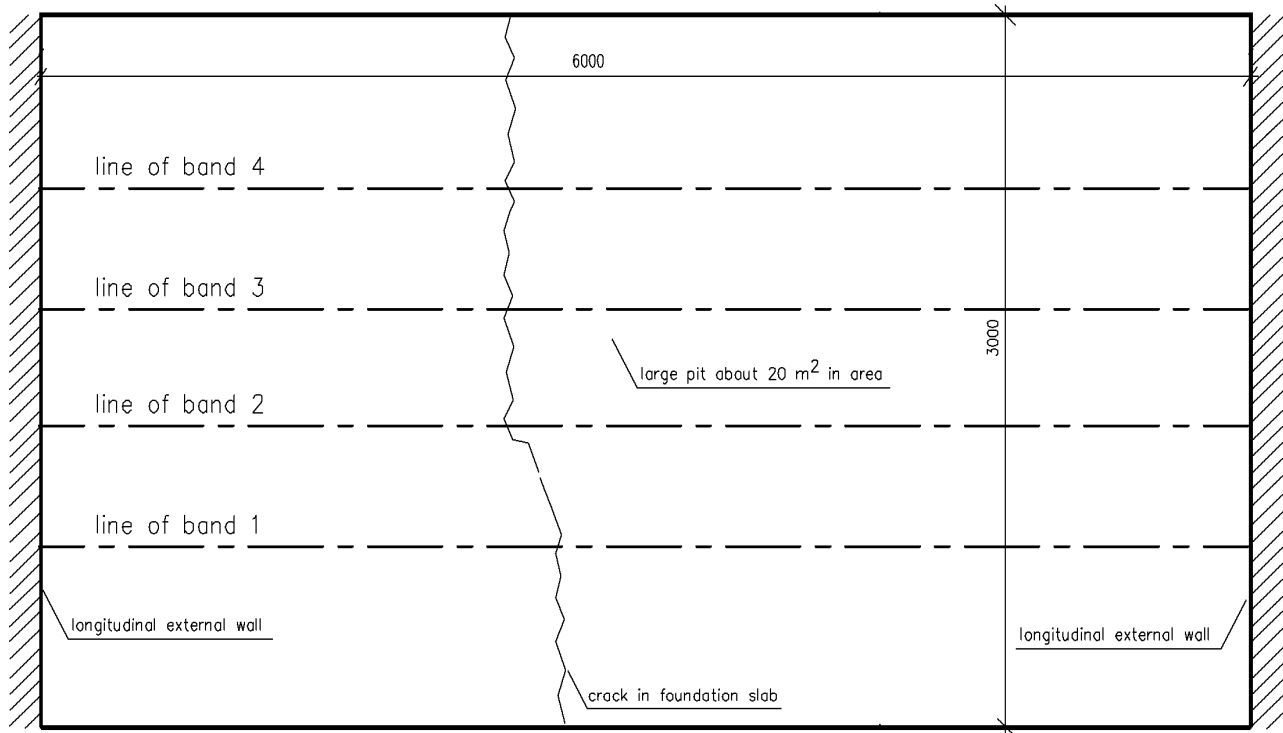
Nondestructive testing of the defective foundation slab began in the large pit where, as previously mentioned, the leaking of water through the visible crack was most intensive (fig. 1). Line of bands were marked on the surface of the groundslab. The arrangement of bands and the location of the crack are shown in fig. 2.

Fig. 2. Grid of line of bands, marked on groundslab within large pit

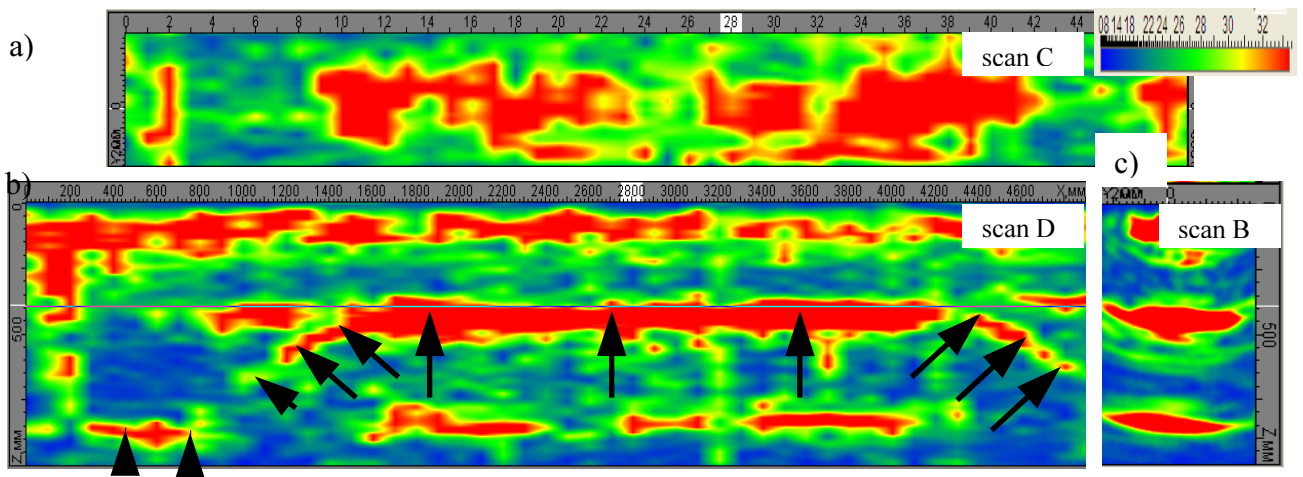
Fig. 4. Exemplary groundslab thickness scans obtained in band 1 by means of ultrasonic tomography: a) scan C, b) scan D, c) scan B

- the thickness of the tested foundation slab in the approx. 1.00 m wide zones adjoining the longitudinal external walls was about 0.80 m and conformed to the design,
- the foundation slab thickness in the approx. 4.00 m wide central zone was 0.36-0.40 m and it did not conform to the design,
- the thinning of the groundslab thickness from 0.80 m to 0.36-0.40 m in the transition zone was made at an angle of  $45^\circ$ ,
- the space under the groundslab in its central zone was probably filled with heterogeneous material, e.g. construction debris.

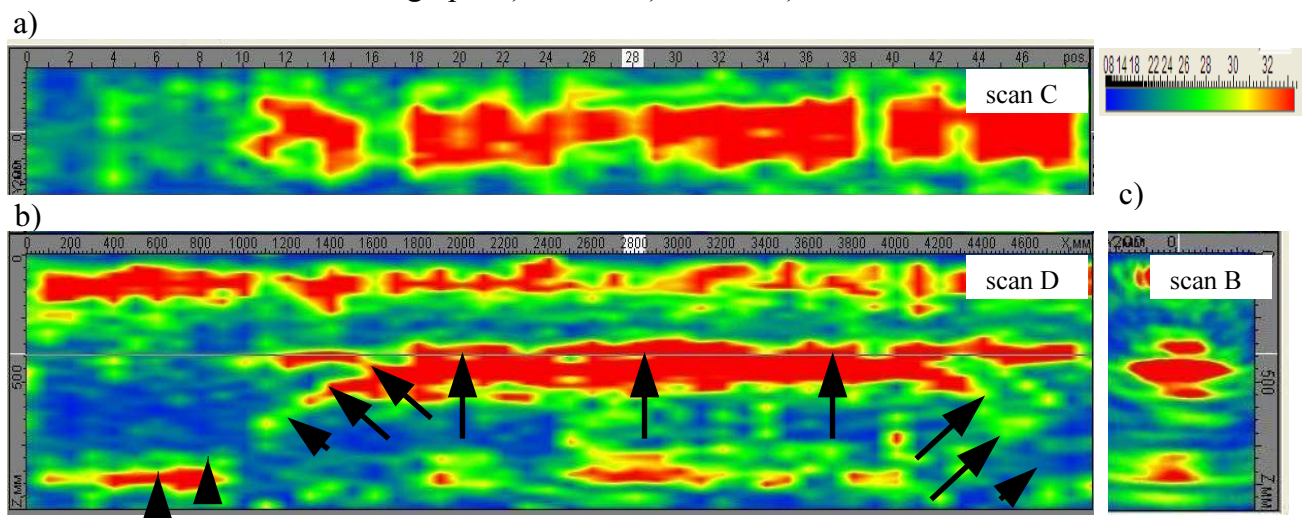
Fig. 5. Exemplary groundslab thickness scans obtained in band 2 by means of ultrasonic tomography: a) scan C, b) scan D, c) scan B

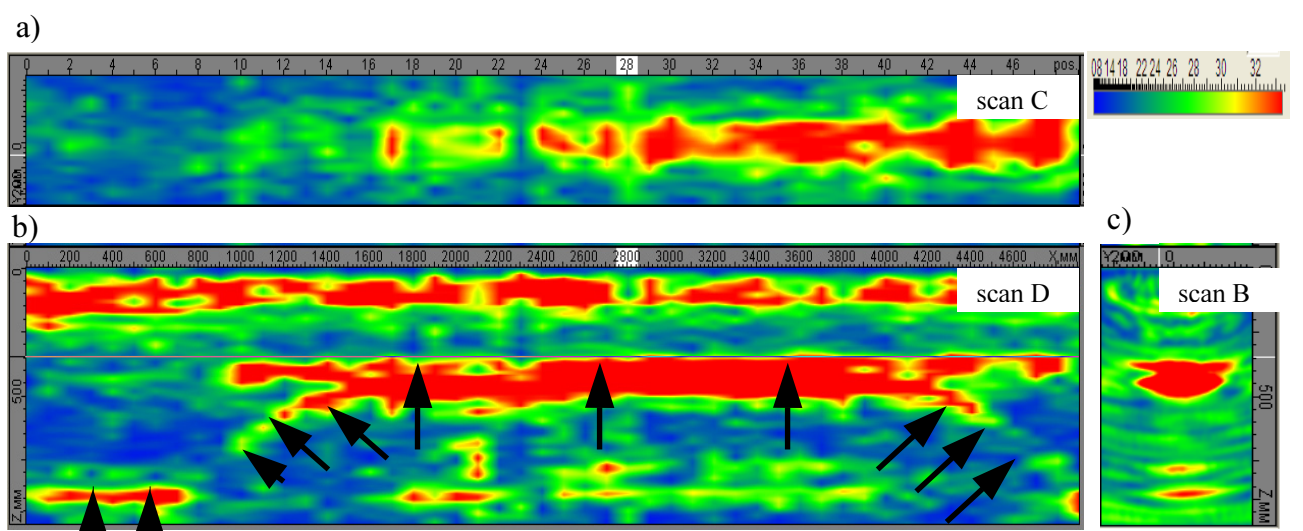
Fig. 6. Exemplary groundslab thickness scans obtained in band 3 by means of ultrasonic tomography: a) scan C, b) scan D, c) scan B

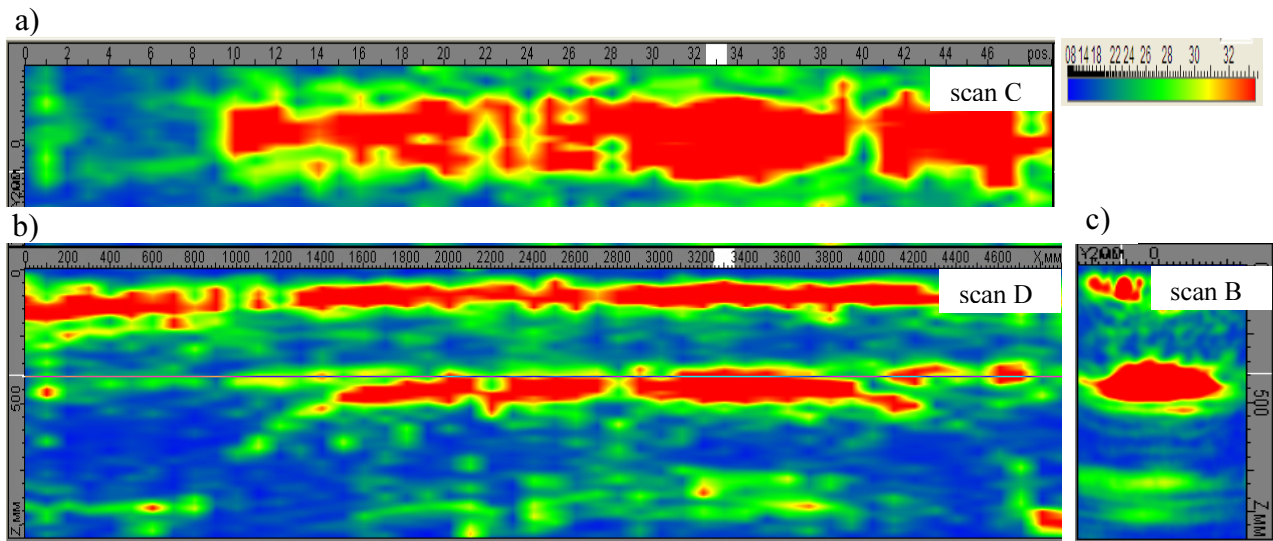
Fig. 7. Exemplary groundslab thickness scans obtained in band 4 by means of ultrasonic tomograph: a) scan C, b) scan D, c) scan B

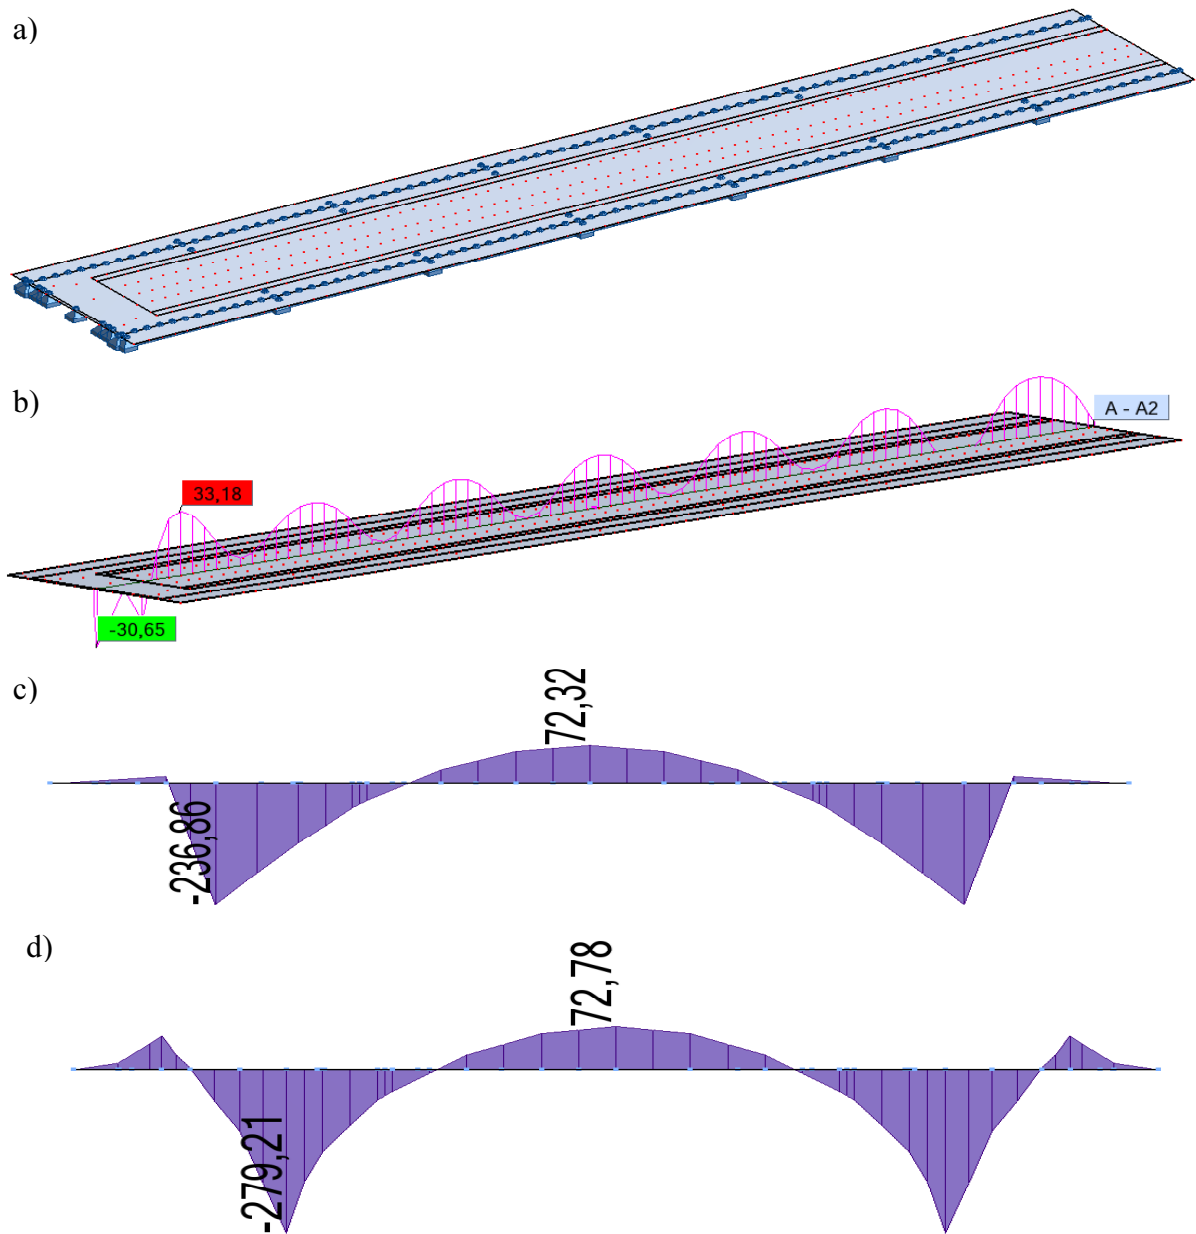
Fig. 9. Groundslab numerical model and calculation results: a) numerical model with marked supports under columns in external walls, and FE mesh, b) diagram of moment  $M_{yy}$  under characteristic loads in longitudinal section, c) diagram of moment  $M_{xx}$  in cross section between columns in external walls, d) diagram of moment  $M_{xx}$  in cross section between columns in external walls

The analyses showed that the groundslab's load-bearing capacity was exceeded by about 45% relative to the design capacity. Considering this fact, it is not surprising that the 50 m long crack appeared in the groundslab. As a result of this long crack, the groundslab's waterproofing could have been damaged whereby groundwater penetrated onto the basement floor. Having the safety of the building in mind, a decision was made to repair and reinforce the groundslab.
