### **1.5.10. QUANTIFICATION OF DAMAGE PROCESSES AT SURFACES AND INTERFACES OF BUILDING STRUCTURES USING OPTICAL METHODS AND ACTIVE THERMOGRAPHY**

Krankenhagen R., Röllig M., Maierhofer Ch., BAM Federal Institute  
for Materials Research and Testing, Berlin, Germany;  
Mecke R., Hofmann M., Schiller M., Fraunhofer Institute for Factory Operation  
and Automation IFF, Magdeburg, Germany;  
Kalisch U., Meinhardt-Degen J., Institute for Diagnosis and Conservation  
on Monuments in Saxony and Saxony-Anhalt (IDK), Halle, Germany

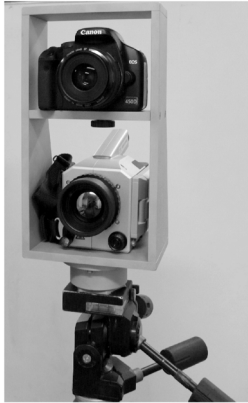
**Fig. 1. Frame with digital camera and IR camera for adjusting of images**

For facilitating the fusion to the 3D data, parallel to the capturing of thermograms digital photos are taken from the measurement area. For this, IR camera and digital camera were both mounted into a common frame structure enabling a reproducible relative position (see fig. 1).

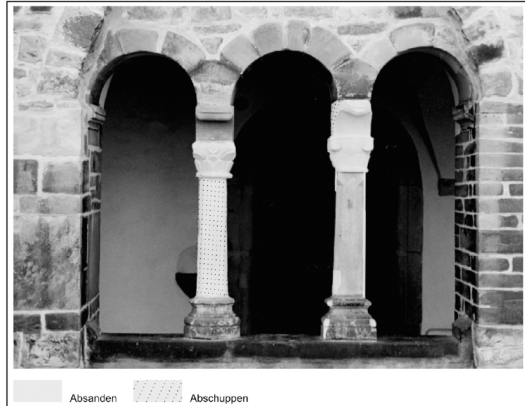
**Fig. 2. Damage at two columns in a cloister**  
(Unser Lieben Frauen, Magdeburg)

Experimental data will be shown on the application of both methods to different damage and structures of historic buildings. One of these case studies is shown in fig. 2. Here, two columns have been investigated showing delaminations and loss of material.
