# STUDY OF THE EFFECTS OF ENVIRONMENTAL PARAMETERS AND IMPACT IN THE COMPRESSIVE STRENGTH OF LAMINATE COMPOSITES.

Santos, M., Amaro A., Santos J.B.

*CEMUC - Centro de Engenharia Mecânica, Faculdade de Ciências e Tecnologia, University of Coimbra, Portugal*

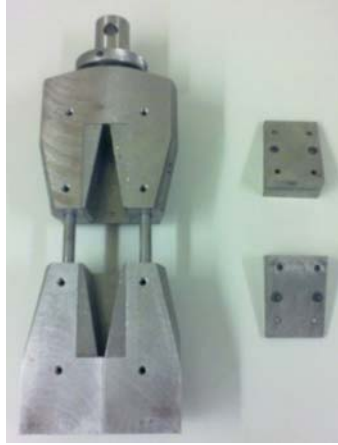
corresponds to an impact velocity of  $1.72 \text{ ms}^{-1}$ . The compression after impact test was carried out using the compression test fixture according to the ASTM D3410 standards, (see Figure 1).

Fig. 1 – Compression-after impact (CAI) test fixture.

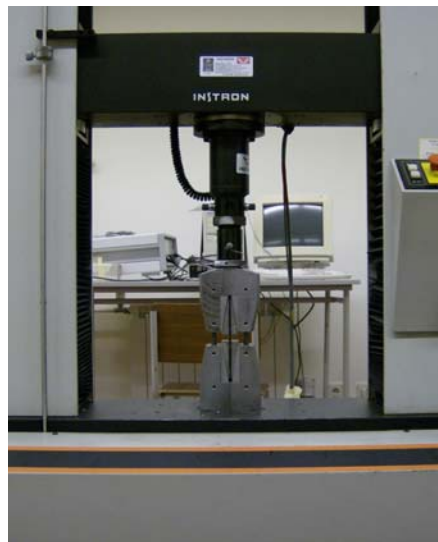
The CAI testing and the tests to determine tensile strength in the plates without defects, are conducted using the INSTRON 4206 tensile testing machine illustrated in Figure 2, with a 50kN load capacity. Compressive load is applied under stroke control at a displacement rate of 1.5 mm/min. During the CAI test, a data acquisition system collects the force versus displacement history. The failure load is obtained from the force-displacement curve. The compressive strength ( $\sigma_c$ ) of the specimen is calculated by using Eq. 1.

Fig. 2 – Compressive strength testing machine.
