# THE ULTRASONIC TOMOGRAPHY TESTS OF CONCRETE IN FOUNDATION SLAB

## Abstract

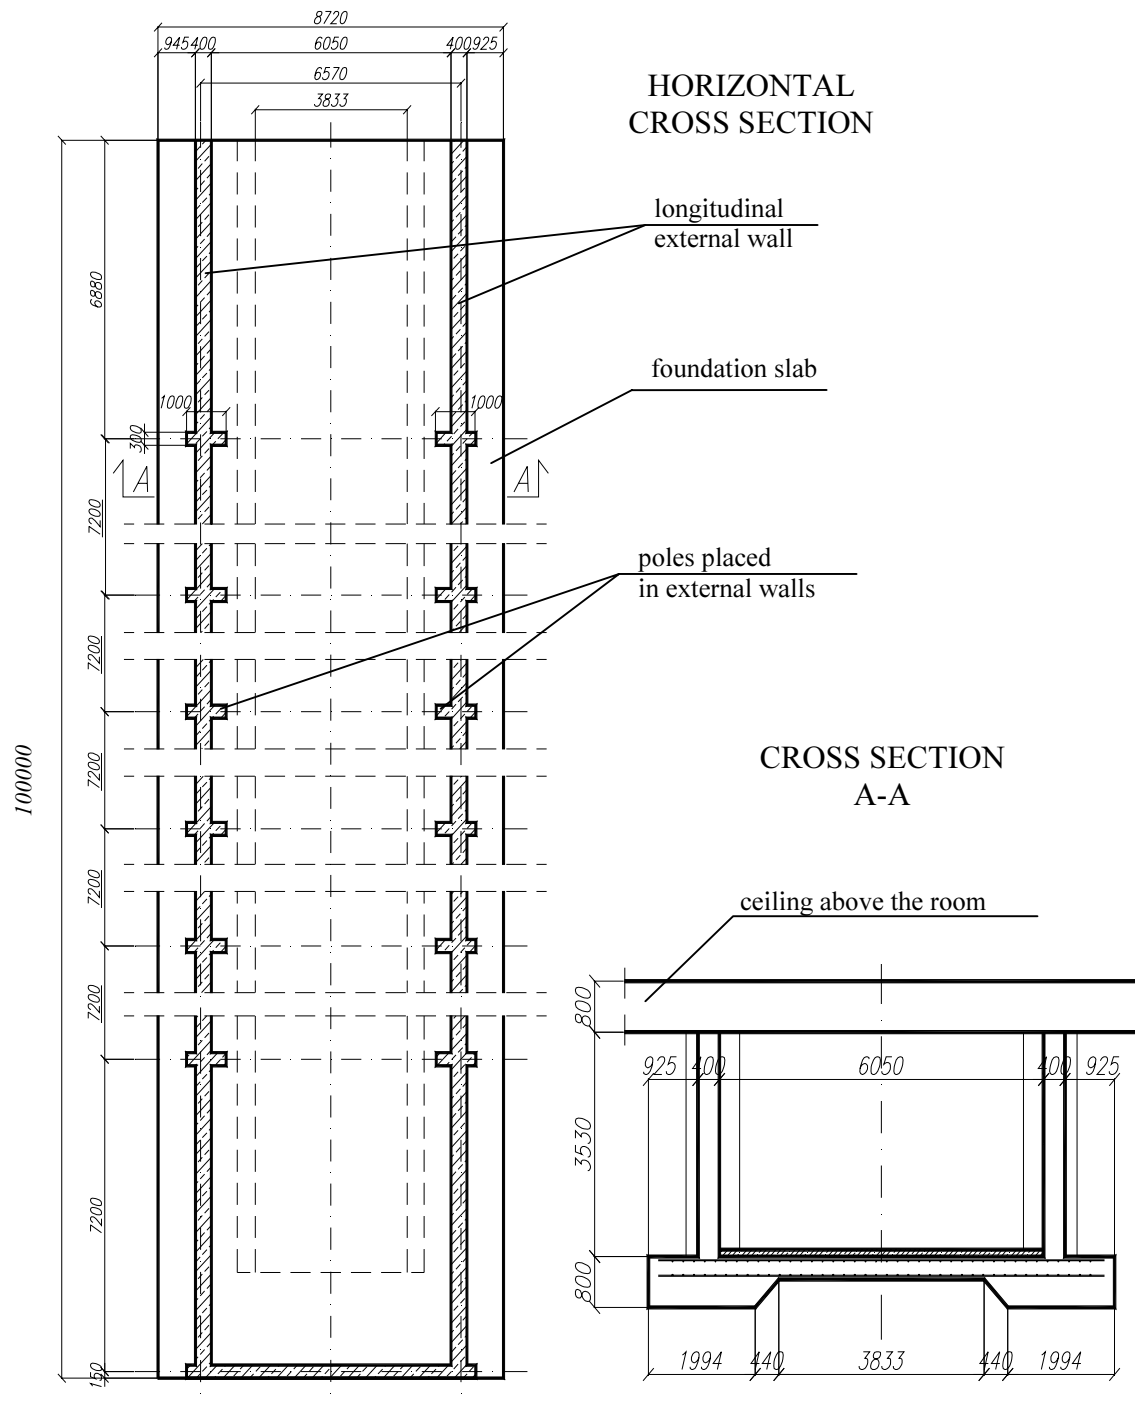
Fig. 8. Groundslab's geometry (plan and cross section)

The Autodesk Robot Structural Analysis software was used for the numerical analyses. The computations were performed for the same loads as those in the building design, taking into account the reduced groundslab thickness in the central zone. The groundslab's geometry is shown in fig. 8. A numerical model of the groundslab with marked supports, and the FE mesh are shown in fig. 9. The total number of finite elements was 1536. Diagrams of moments in the longitudinal section and in the cross section are shown in fig. 9.

The analyses showed that the groundslab's load-bearing capacity was exceeded by about 45% relative to the design capacity. Considering this fact, it is not surprising that the 50 m long crack appeared in the groundslab. As a result of this long crack, the groundslab's waterproofing could have been damaged whereby groundwater penetrated onto the basement floor. Having the safety of the building in mind, a decision was made to repair and reinforce the groundslab.
