# GUIDED WAVES EXPERIENCE FOR MONITORING DISTRICT HEATING PLANT FOR CORROSION EVALUATION TEST

G. Nardoni<sup>(1)</sup>, M. Certo<sup>(1)</sup>

<sup>(1)</sup> I&T Nardoni Institute

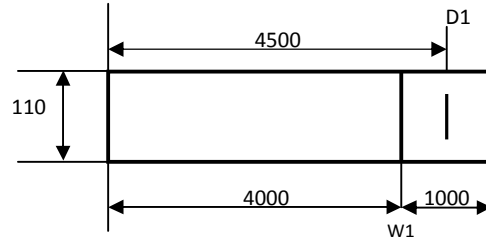
This simple sample was designed for a fast check of instrument performance with particular reference to the axial or longitudinal resolution power. In fact, the big and sharp defect is placed in the middle of a short pipe piece, only 1 m long, welded to another pipe piece 4 m long.

Figure 1: sample 1 sketch

defect D1 is an artificial full penetration slit defect with circumferential orientation and a width of 84 mm with a reduced area of 26%. Inspection has been carried out with a 16 transducer per ring collar probe placed at 1 m from the beginning working only in T(0,1) torsional mode at frequencies of 28 kHz, 36 kHz, 44 kHz, 64 kHz.

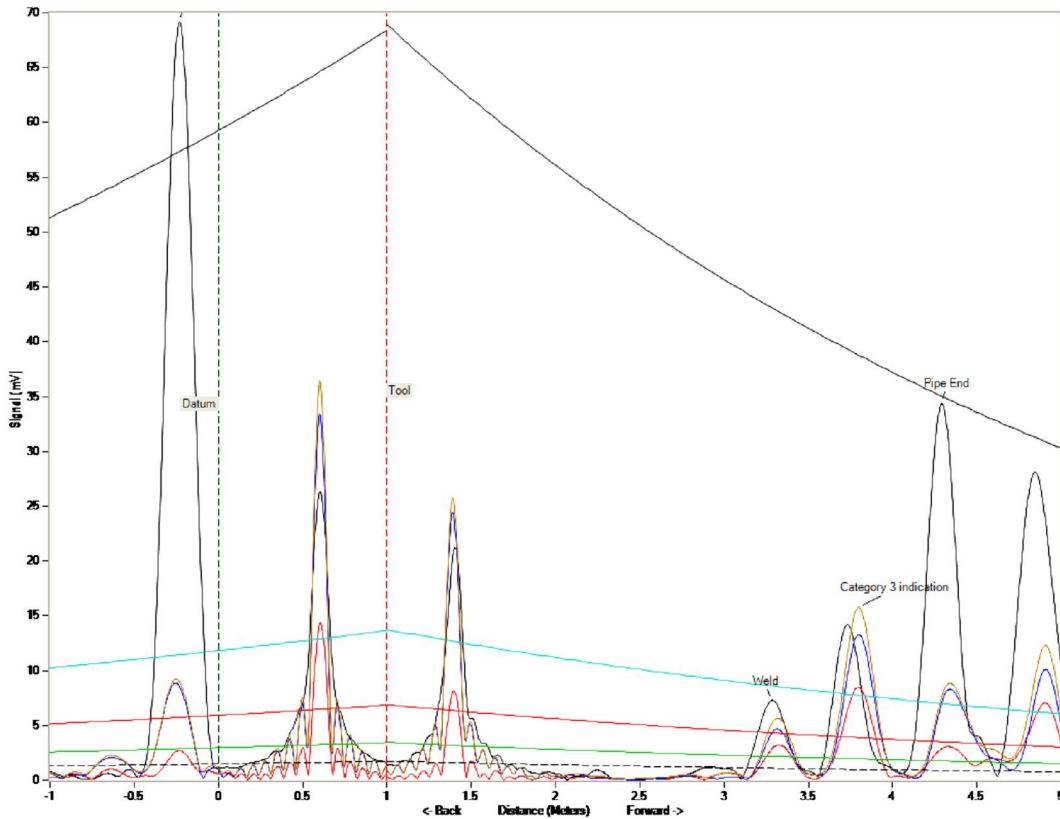
Figure 2: echo signal A-scan @ 44 KHz on sample 1

Figure 2 shows the best A-scan obtained at 44 kHz. The high flexural components are present in the A-scan confirming the non axial symmetric nature of the defect; further, echo amplitude is in good agreement with the defect reduced area. With a frequency of 28 kHz, axial resolution is at its limit, that is 0.5 m, while at 44 kHz axial resolution is quite good and can be estimated in 0.25 m.

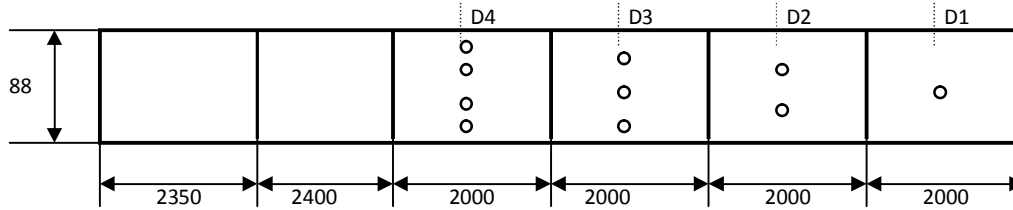
This sample was designed to check system sensitivity against a series, four, of calibrated and axial symmetric defect with calibrated reduced area of 2.5% (D1), 5% (D2), 7.5 (D3), 10 % (D4).

Figure 3: sample 2 sketch

Each series of defects is composed by a number of artificial defects equally spaced around the pipe circumference. Each defect is obtained with a spherical grinding tool in order to have a very smoothed discontinuity; in this way it is possible to check the influence of low axial gradient of discontinuity on the overall system sensitivity. The reduced area of each hemispherical defect is about 0.625 %; the different reduced are of the four series is obtained with a different number of hemispherical defects.

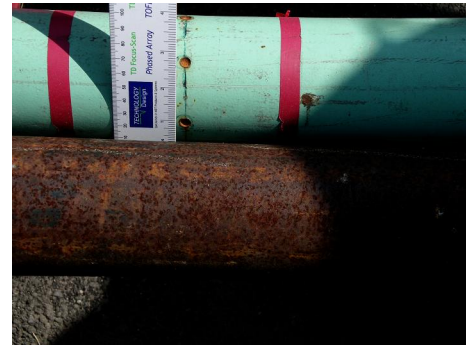
Figure 4: photo of defect shape

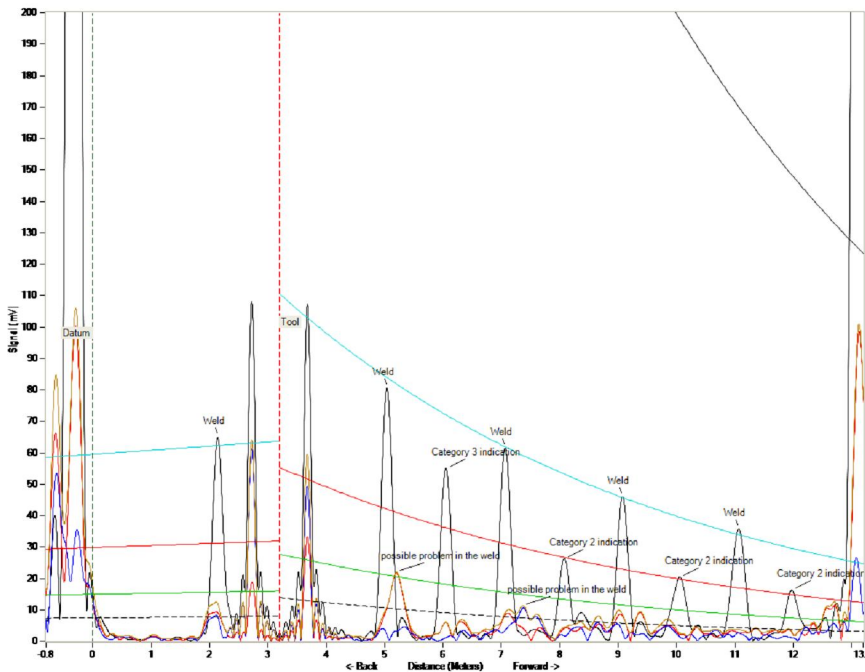
Figure 4: echo signal A-scan @ 36 KHz on sample 2

results are obtained at 36 kHz, figure 5, and 44 kHz, figure 6. At 36 kHz all the defects are well detected with higher amplitudes than expected, especially the smallest ones which, as shown in the figure, seems to be of same category of the second one. This is probably due to the axisymmetric nature of such defect type. At 44 kHz the defects, as shown in figure 6, are still detected with higher amplitudes than expected even if the amplitude trend seems monotonically decreasing except for the smallest defect which is highly disturbed by unwanted component at the pipe end.

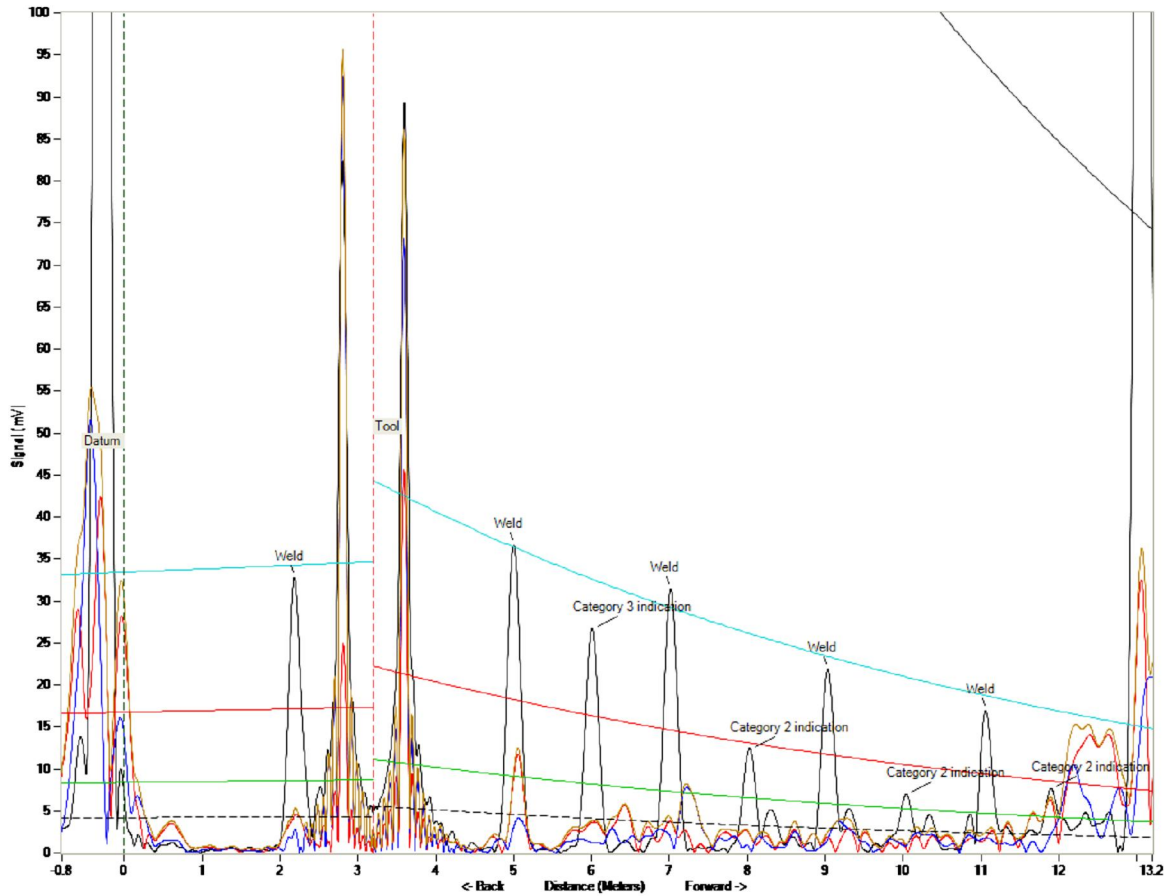
Figure 6: echo signal A-scan @ 44 KHz on sample 2

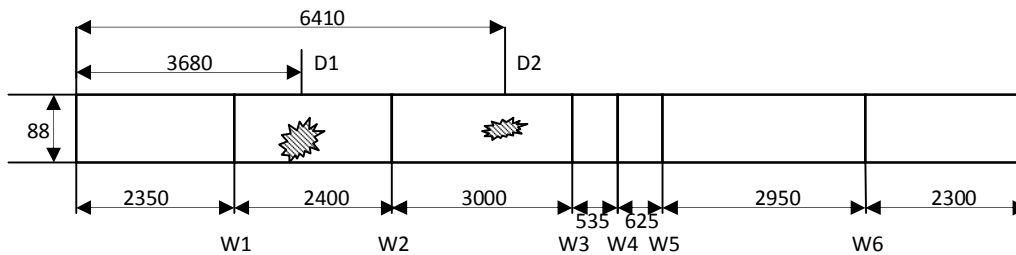
Figure 7: sample 3 sketch

This procedure consists in grinding a given area on the outer pipe surface in a random way in order to simulate the shape of corroded area. An accurate dimensional characterization of such random grinding gives the possibility to evaluate the effective reduced area. Two grinded artificial defect was produced, as shown in figure 7, with the following characteristics:

- D1: width = 123 mm; length = 55 mm; reduced area = 16,32 %;
- D2: width = 10 mm; length = 70 mm; reduced area = 7,76 %

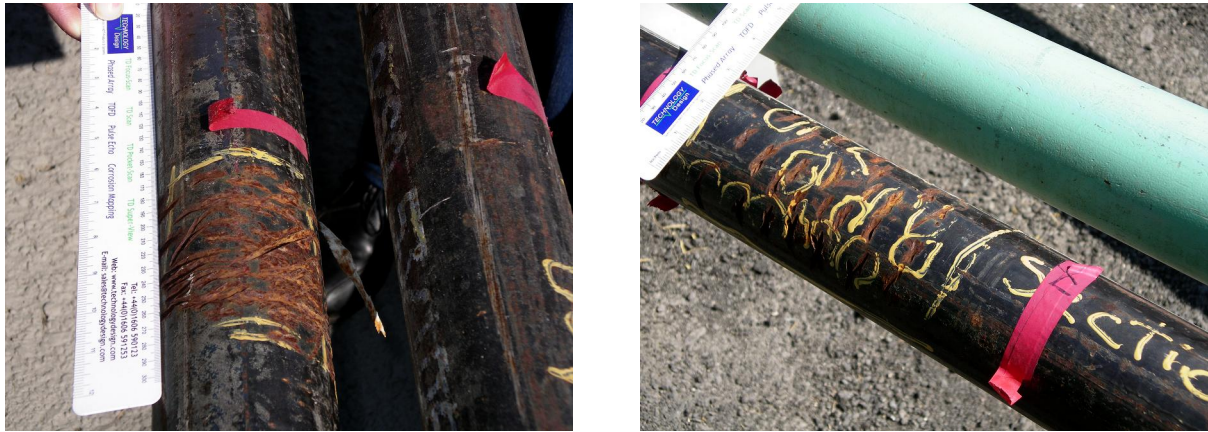
Figure 8 shows photos of such defects.

Figure 8: random grinded defects on sample 3

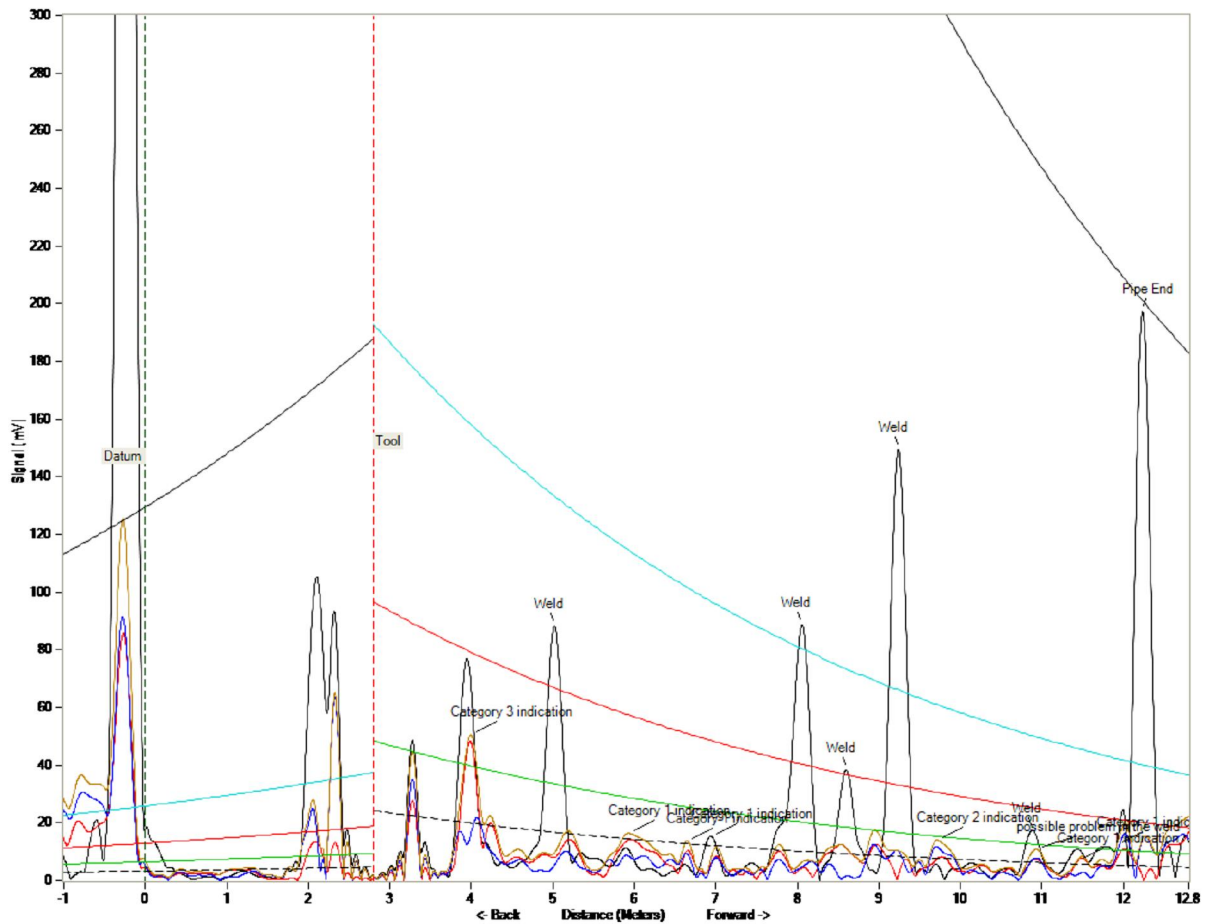
Inspection was carried out with a12 transducer per ring collar working in T(0,1) torsional wave mode and the best frequency was found at 36 kHz. Reflections from welding are not monotonic due to the above mentioned non uniform thickness. As shown in figure 9, both defect D1 and D2 are clearly detected with a good correspondence of relevant echo amplitudes to the defects reduced area, while high amplitude flexural components are presents due to asymmetric nature artificial defects.

Figure 9: echo signal A-scan @ 36 KHz on sample 3

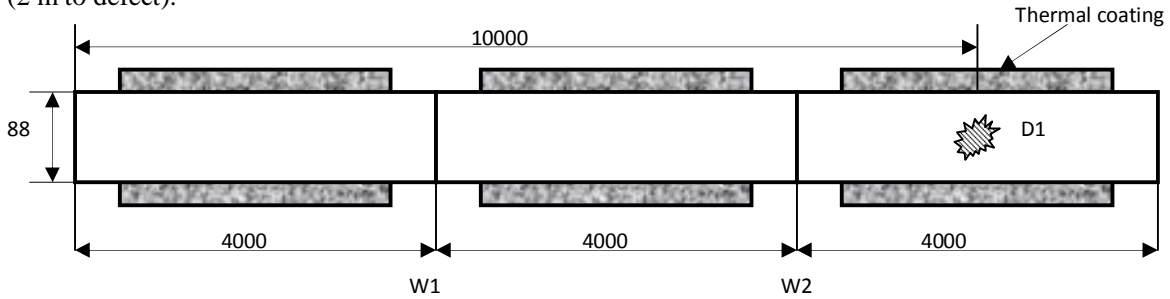
This is the first sample with coating and its outer diameter of 88 mm is the smallest one in the application of district heating plan corresponding to the *last mile* of the plant. The sample design is shown in figure 9 and allows to place the probe collar in two position corresponding to weld W1 (6 m from defect) and to weld W2 (2 m to defect).

Figure 9: sample 4 sketch

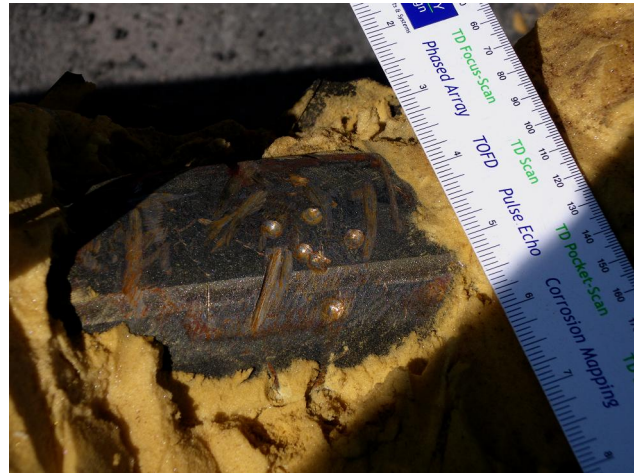
The grinded artificial defect manufactured as in sample 3 is 72 mm width and 45 mm length, with a reduced area of 12%.

Figure 10: photo showing the defect on sample 4

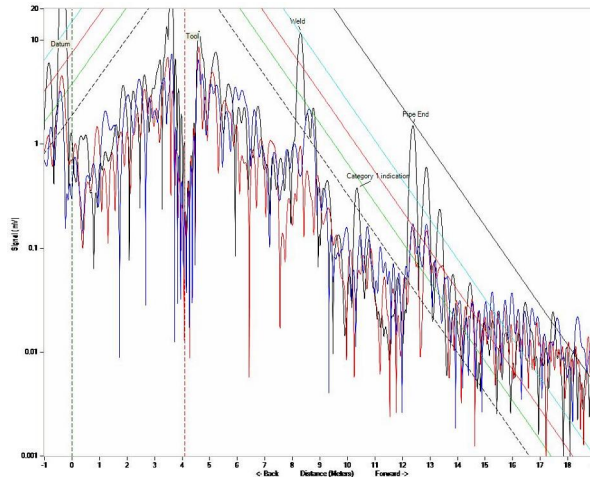
Figure 11: echo signal A-scan @ 36 KHz on sample 4

When the 12 transducer per ring collar, working only in T(0,1) torsional mode, was placed at position 1 (first welding W1) the best frequency was founded at 36 kHz, and 72 kHz. Figure 11 and 12 show the relevant echo signal with a logarithmic representation vertical scale. Such a representation allows the determination of the maximum inspection length which at a threshold level of 2.5 % is about 8 m at 36 kHz, while is about 6 m of max inspection length at 72 kHz; but assuming a threshold level of 10% DAC the max inspection length at 36 kHz is about 10 m, while at 72 kHz is 8 m.

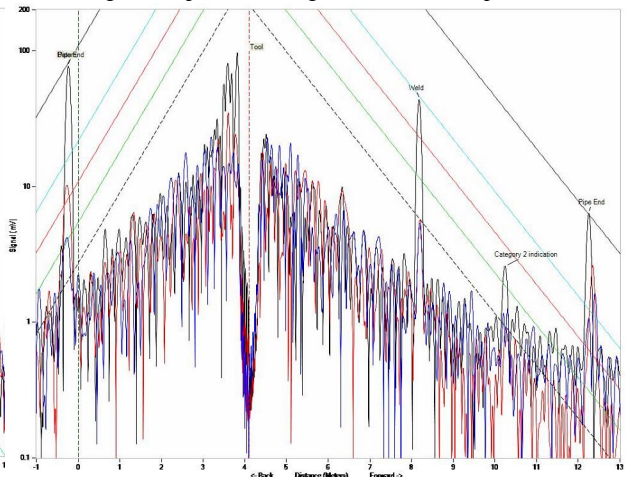
Figure 12: echo signal A-scan @ 72 KHz on sample 4

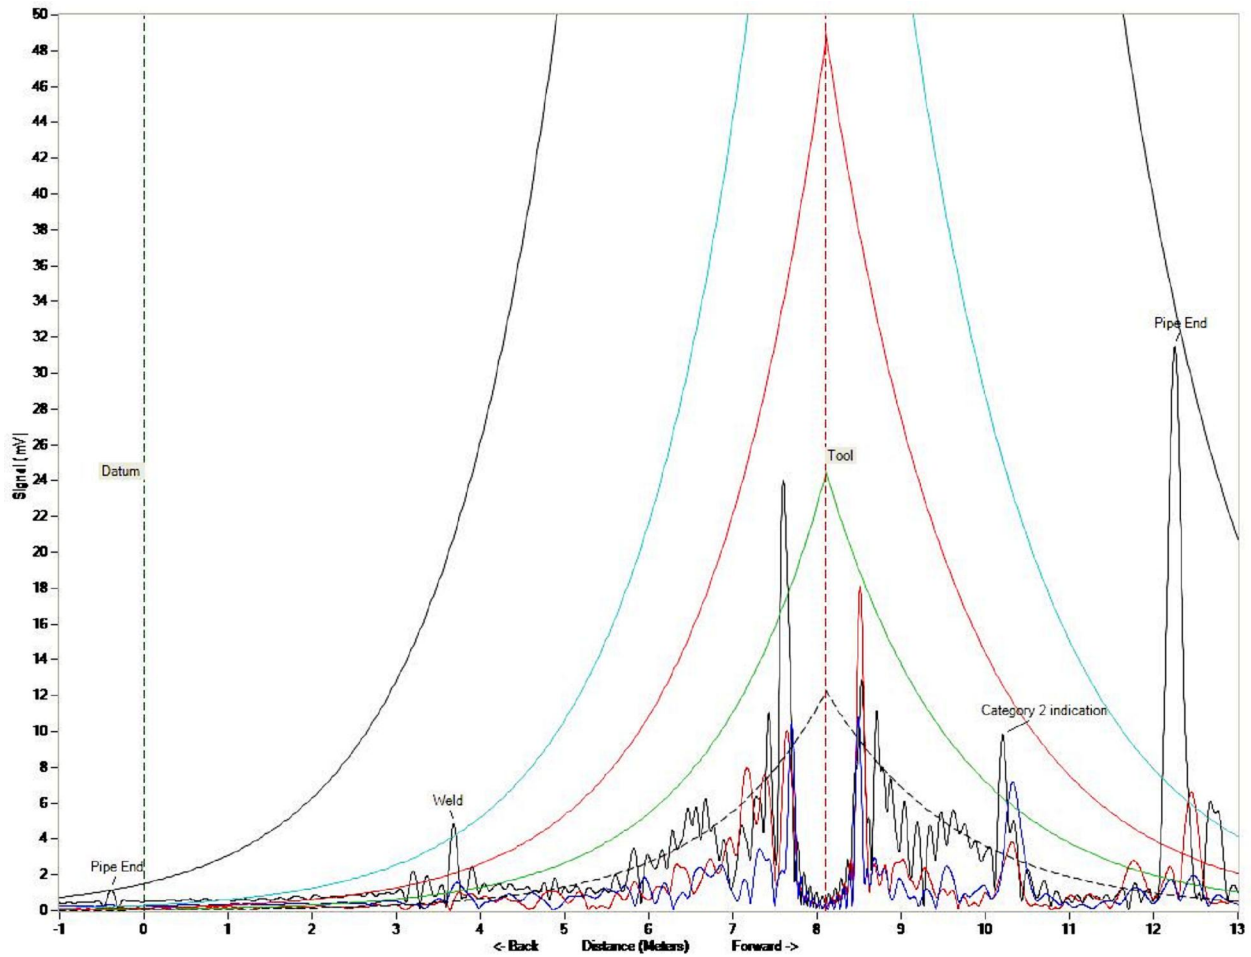
Figure 13 shows the A-scan at 72 kHz relevant to T(0,1) torsional wave with linear representation and with the collar probe in position 2 (second welding W2). The 72 kHz defect echo amplitude at both position 1 and 2 is in quite good agreement with defect reduced area even if at 36 kHz amplitude is slightly underestimated.

Figure 13: echo signal A-scan @ 72 KHz on sample 4 in position W2

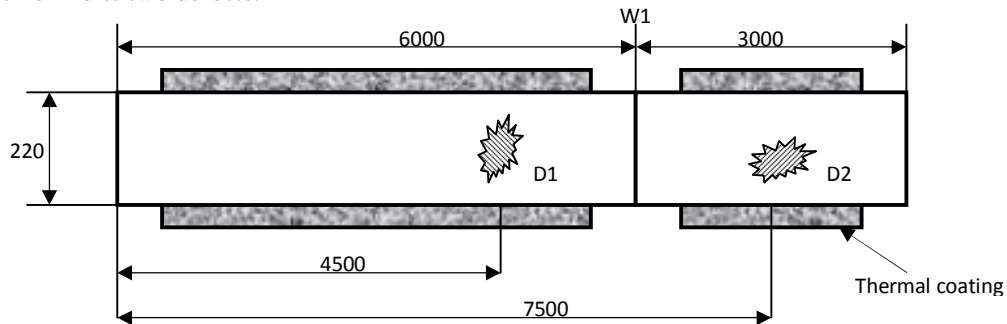
The second coated sample has 220 mm of outer diameter; figure 14 shows the sample sketch of the sample which exhibits two defects.

Figure 14: sample 5 sketch

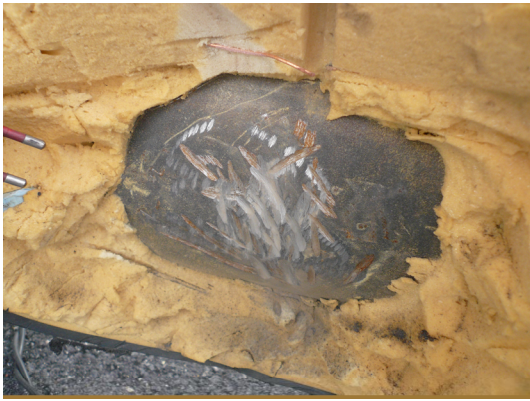
Figure 15: Defect D1 (left): width 100 mm, length 80 mm, reduced area 2,6%.

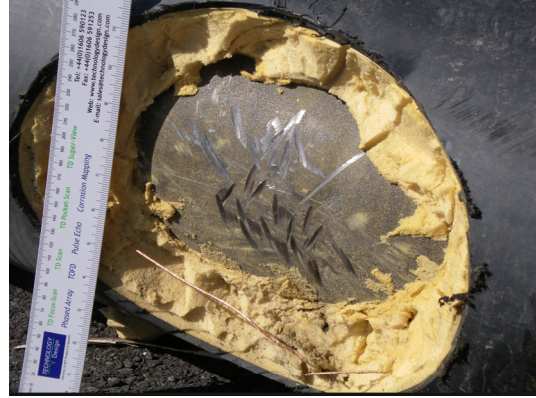
Figure 16: defect D2 (right): width 80 mm, length 92 mm, reduced area 5,8%

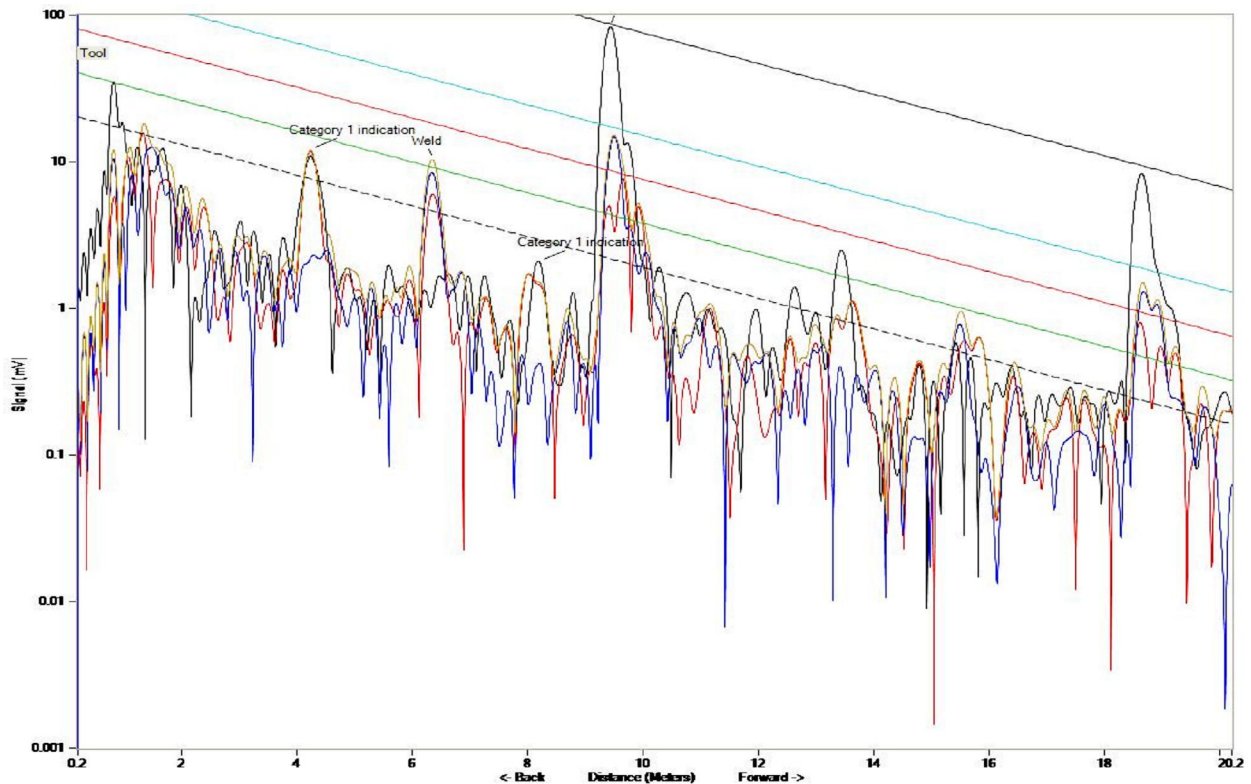
Since this sample has a sufficiently high diameter, a 24 transducer per ring collar working in multimode has been used and placed at the beginning of sample. Figure 17 shows A-scan at 46 kHz L(0,2) longitudinal wave. In this case the maximum inspection length is about 20 m, while at 81 kHz T(0,1) torsional wave, shown in figure 18, the maximum distance is about 15 m of max. Again, if we assume a 10% DAC threshold, this distance reaches 25 m. In all the case the defect echo amplitudes are in quite good coherence with the relevant reduced area.

Figure 17: echo signal A-scan @ 46 KHz, L(0,2) wave on sample 5

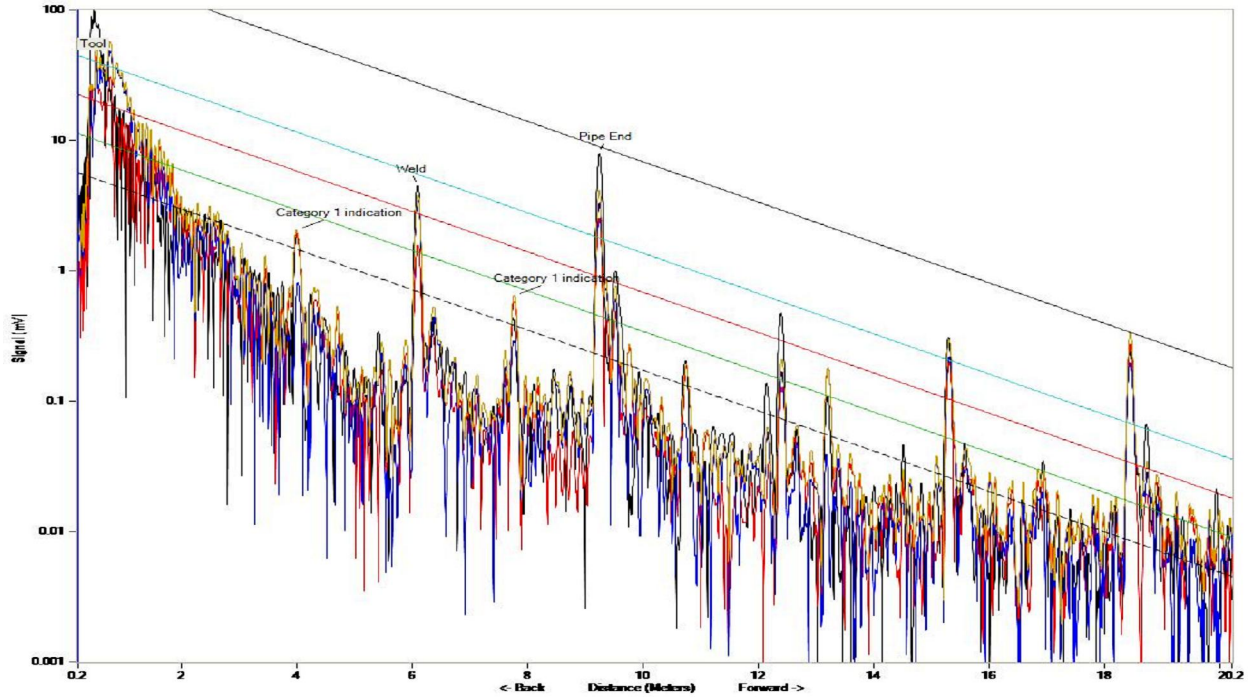
Figure 18: echo signal A-scan @ 81 KHz, T(0,1) wave on sample 5

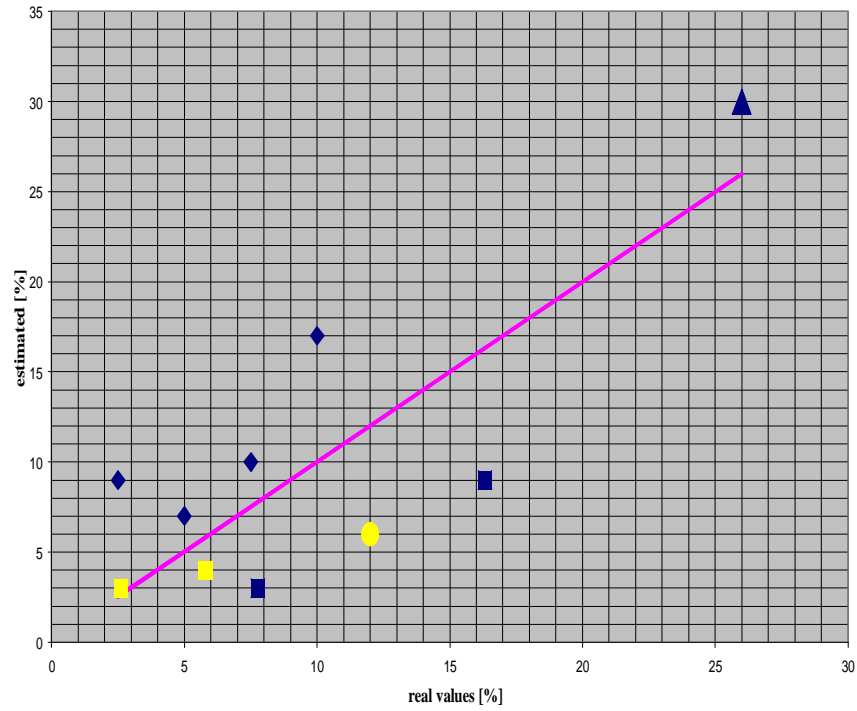
Figure 19: graphical comparison of estimated reduced area against real values.  
Yellow dots are relevant to coated pipes sample 4 and 5

We can observe that corrosion like defects on coated sample are generally a bit underestimated but, since GW method is of screening type, this is not really a problem. What is important is that all the defects are always well detectable and this means that the inspection of district heating plant can be reliably carried out with the Guided Wave method.

The experiments carried out on the two last coated sample demonstrate the feasibility of the inspection for this type of plant; in the worst case maximum inspection length is of the order of 8 m, but this length can increase to about 12 ó 15 m if we take account that for the pipe of this plant type an effective alarm threshold for reduced area could be greater than 10 %. Table II summarizes defect echo amplitudes compared defect by defect with the relevant real reduced area.
